DEPARTMENT OF TRANSPORTATION

Contract #: 04-0120F4Cty: SF/ALA Rte: 80 PM: 13.2/13.9File #: 13.28**WELDING INSPECTION REPORT****Resident Engineer:** Pursell, Gary**Address:** 333 Burma Road**City:** Oakland, CA 94607**Report No:** WIR-014539**Date Inspected:** 03-Jun-2010**Project Name:** SAS Superstructure**OSM Arrival Time:** 1000**Prime Contractor:** American Bridge/Fluor Enterprises, a JV**OSM Departure Time:** 1830**Contractor:** Oregon Iron Works Clackamas, Or.**Location:** Clackamas, OR

CWI Name:	M. Gregson, J. Salazar, G. Mundt			CWI Present:	Yes	No	
Inspected CWI report:	Yes	No	N/A	Rod Oven in Use:	Yes	No	N/A
Electrode to specification:	Yes	No	N/A	Weld Procedures Followed:	Yes	No	N/A
Qualified Welders:	Yes	No	N/A	Verified Joint Fit-up:	Yes	No	N/A
Approved Drawings:	Yes	No	N/A	Approved WPS:	Yes	No	N/A
				Delayed / Cancelled:	Yes	No	N/A
Bridge No:	34-0006			Component:	Hinge K Pipe Beams

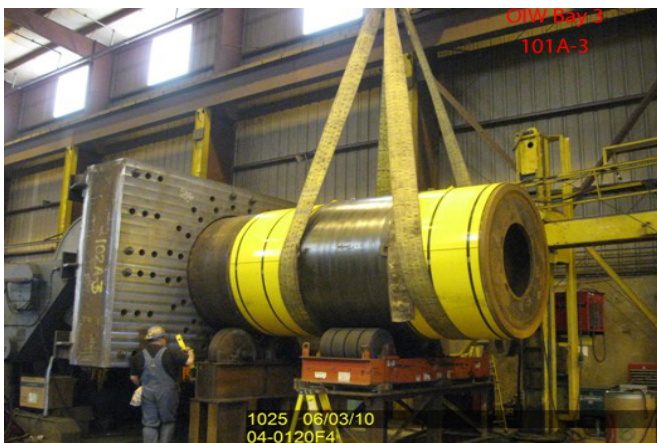
The QA Inspector observed OIW WID #B62 (Marcus Belgarde) and Production Lead Troy Smith attaching two yellow rigging slings to the Fuse 120A-3. The QA Inspector observed that the Fuse was sitting on a shipping saddle and wooden dunnage, on the Production Bay 3 shop floor. The QA Inspector observed that the slings were being placed around the Fuse and the overhead Bay 3 crane had been previously placed to lift the Fuse. The QA Inspector then observed OIW lower the crane and attach the slings to the lifting hook. Once the hook was attached, the QA Inspector observed OIW utilize the hand held controls, which operate the crane, to lift the Fuse from the shop floor. Once lifted from the shop floor, the QA Inspector observed that the Fuse was then moved in the east direction and lowered on a set of previously placed mechanical rollers. The QA Inspector then observed OIW remove the crane hook and slings from the Fuse and start fitting the Fuse to the previously placed assembly 102A-3.

Lead Smith explained that fitting will continue throughout the shift and once the fit-up is complete, tack welds will be placed. Lead Smith explained that once the joint is tack welded, an OIW machinist will then perform FARO measurements on the perpendicularity of the Fuse to Forging assembly and QC will then be notified to visually check the fit-up. See attached picture below.

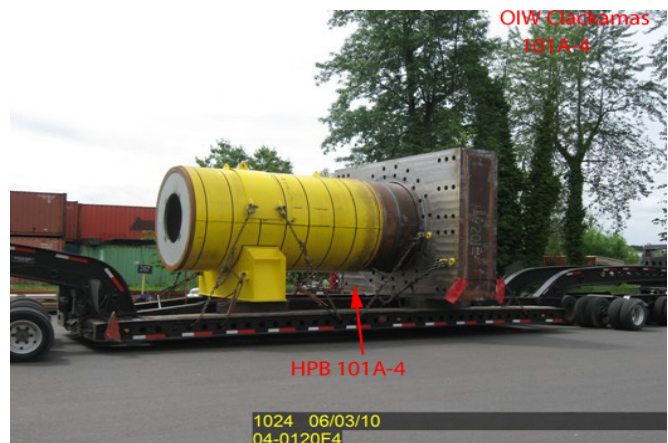
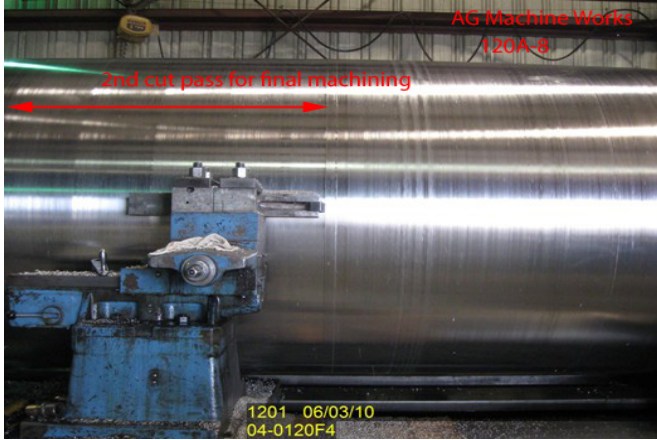
On this date, the QA Inspector arrived at AG Machine Works to observe the final machining of the Fuse 120A-8. Upon arrival, the QA Inspector met with AG Machinist Terry Schmale. Mr. Schmale explained that the second cut pass for final machining was in-process and approximately 50 % complete and AG will continue to machine throughout the day.

The QA Inspector observed that the Fuse was rotating in a horizontal lathe and a stationary steel cutting bit was removing the overlay material, as the Fuse rotated.

Mr. Schmale explained that AG will be closed on the following day, 6/4/10 and will resume machining on 6/7/10. See attached pictures below.
